ATN Inspection Services, LLC

Property Inspection Report

2346 Anystreet, Anytown, AR 79999
Inspection prepared for: John Client
Date of Inspection: 2/1/2015 Time: 14:00
Age of Home: 8 Size: 1780
Weather: Overcast, 41 degrees

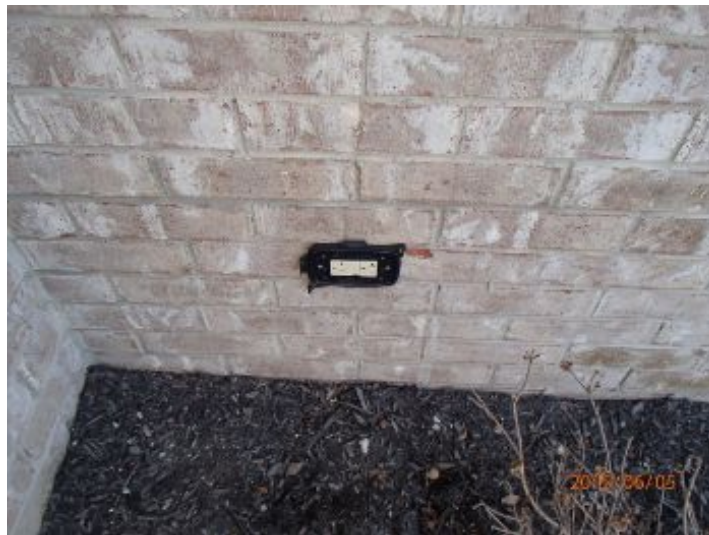
Damaged/missing receptacle cover near front entry

- GFCI was tested and operated correctly.
- Broken/Missing water proof cover noted at exterior outlet, repairs recommended for enhanced safety to occupants.

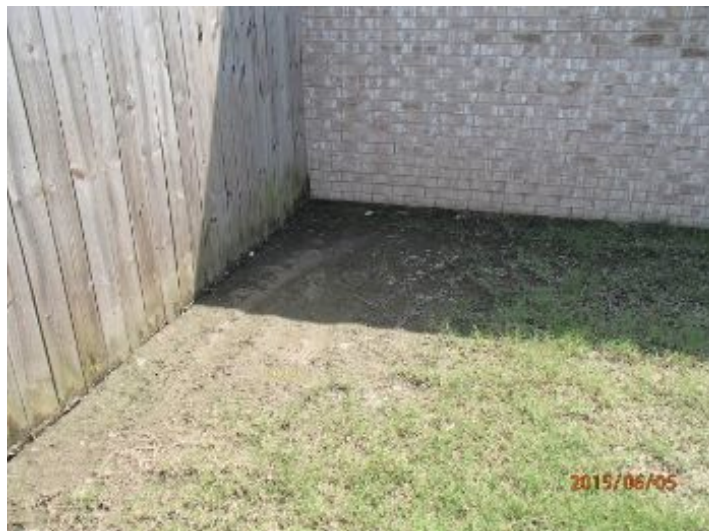
Observations:
 • Lot appears to be mostly flat with very limited slope for water drainage away from structure <FYI>
 • Improper slope or low spot of grading near foundation noted. Recommend upgrading drainage to prevent water intrusion into structure.

Poor drainage. French drain, regrading or other repairs needed

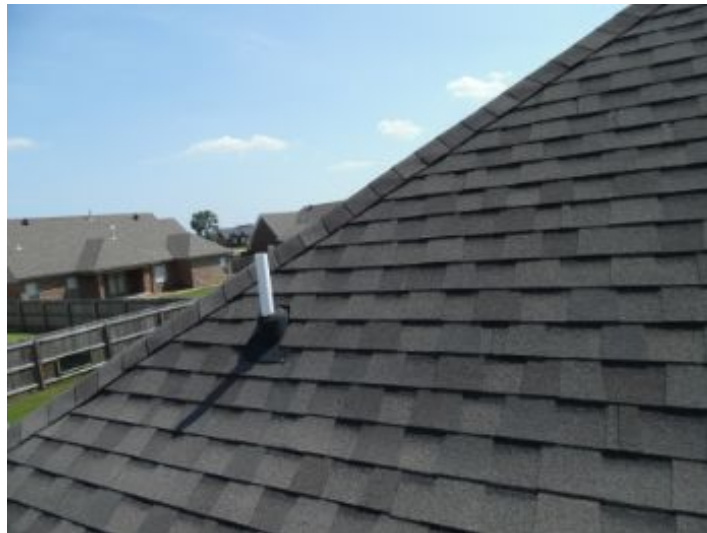
Boots at plumbing penetrations require more frequent repair/replacement than roof covering.

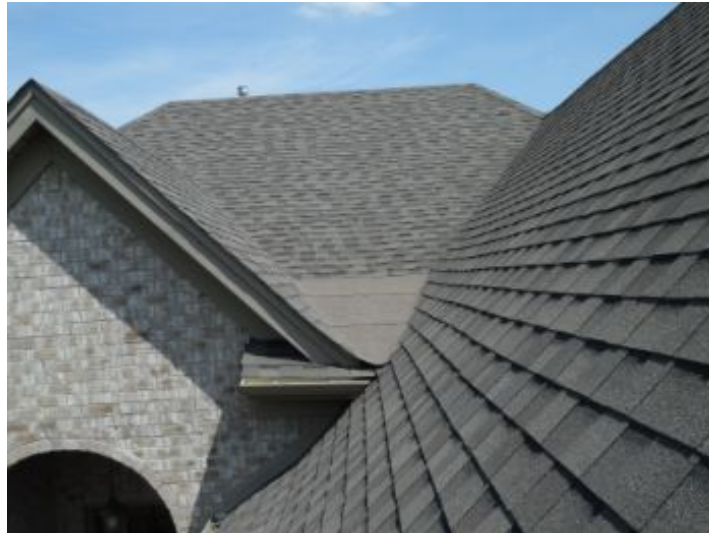
Recommend annual inspection of material/seams and removal of debris to extend the roofs useful lifespan.

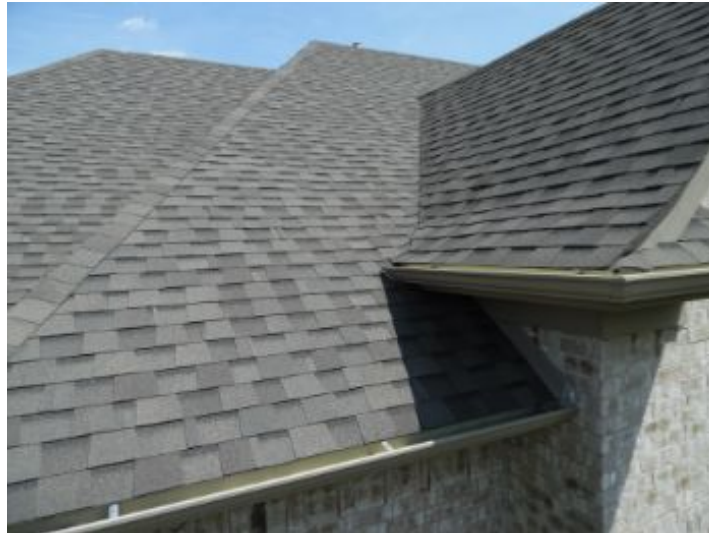
- Shingles appear to be 5-10 years into the 20-25 year average service lifespan for this type of roofing material.
- Shingles appear to be in serviceable condition at time of inspection. With PROPER maintenance roof should have a minimum of 5 years of service life left. Recommend annual review of shingles for signs of cracking, curling, missing shingles, loss of granules, moss growth and exposed fasteners. The normal life expectancy of asphalt shingles is 15-25 years. Shingles can wear out prematurely due to improper/lack of attic ventilation, recommend evaluation of ventilation performance by a qualified roofing contractor to assure that sufficient ventilation is present which will void most shingle manufacturers warranty due to improper installation practices.

Shingles appear to be in serviceable condition at time of inspection. With PROPER maintenance roof should have a minimum of 5 years of service life left. Recommend annual review of shingles for signs of cracking, curling, missing shingles, loss of granules, moss growth and exposed fasteners. The normal life expectancy of asphalt shingles is 15-25 years. Shingles can wear out prematurely due to improper/lack of attic ventilation, recommend evaluation of ventilation performance by a qualified roofing contractor to assure that sufficient ventilation is present which will void most shingle manufacturers warranty due to improper installation practices.

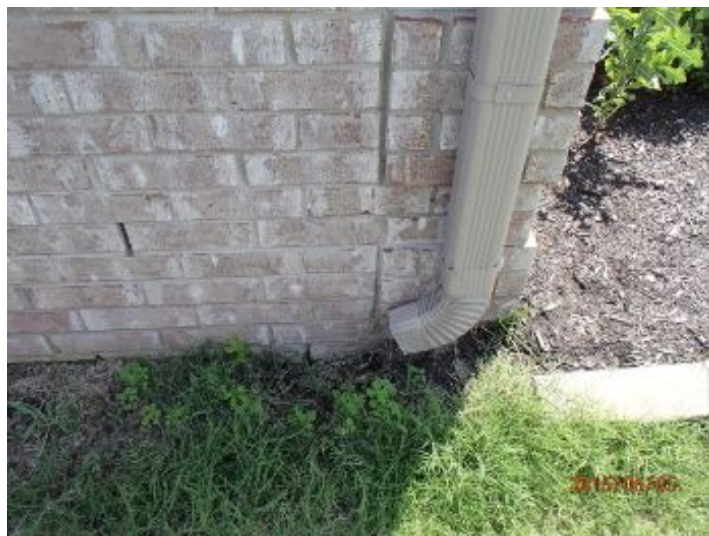
Observations:
 • Recommend addition of properly installed gutters and downspouts to enhance water drainage away from structure.
 • Partially installed in areas
 • Recommend extending downspouts to enhance drainage AWAY from structure.

Recommend extending downspouts to enhance drainage AWAY from structure.

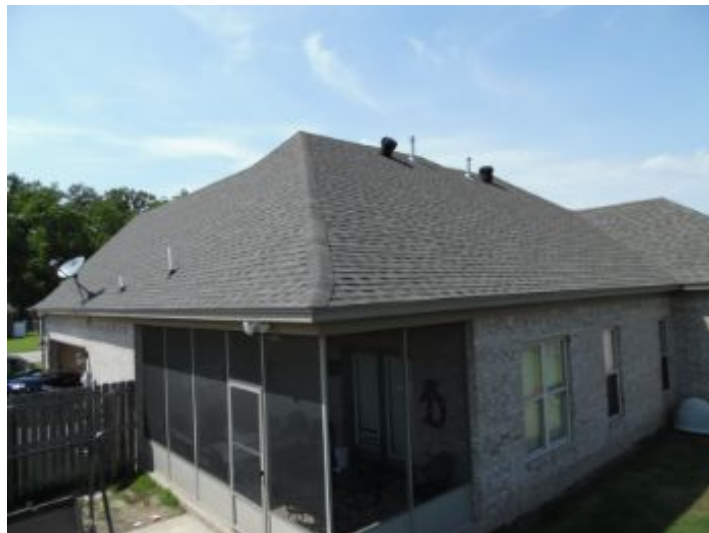
- Homes ventilation appears to be insufficient, recommend evaluation by qualified roofing contractor for suggestions on upgrading to extend the shingle life expectancy.
- Turbine vent is damaged and is not functional.

Turbine vent is damaged

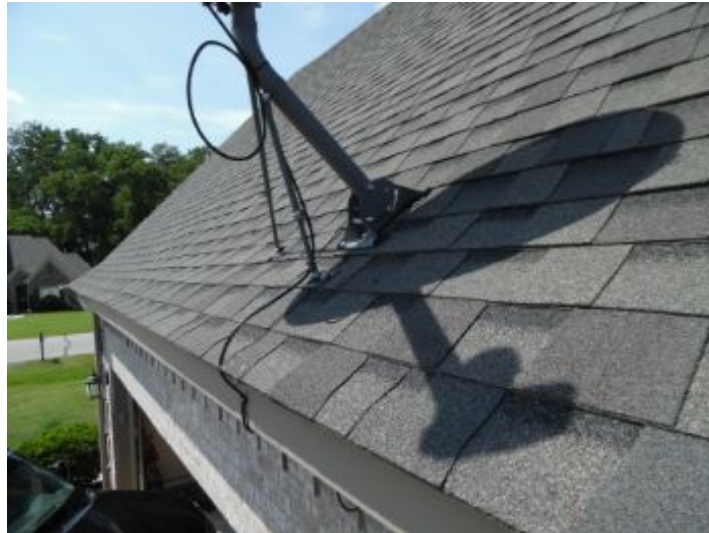
Satellite dish/antenna was observed mounted directly to shingles. This is considered poor practice as wind can cause fasteners to loosen which causes caulking failure. Moisture intrusion can lead to structural damage if left undetected due to lack of maintenance. Recommend relocating to a better suited location to prevent potential roof leaks in the future.

- Satellite dish/antenna was observed mounted directly to shingles. This is considered poor practice as wind can cause fasteners to loosen which causes caulking failure. Moisture intrusion can lead to structural damage if left undetected due to lack of maintenance. Recommend relocating to a better suited location to prevent potential roof leaks in the future.

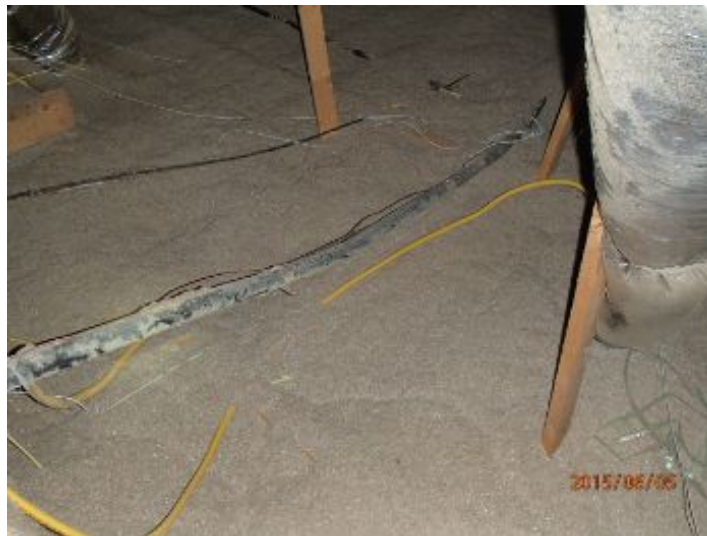
Attic Insulation Condition

Materials: loose fill, blown in insulation
Depth: 3-6 inches

- Functional
- One or more areas not accessible for inspection of insulation.

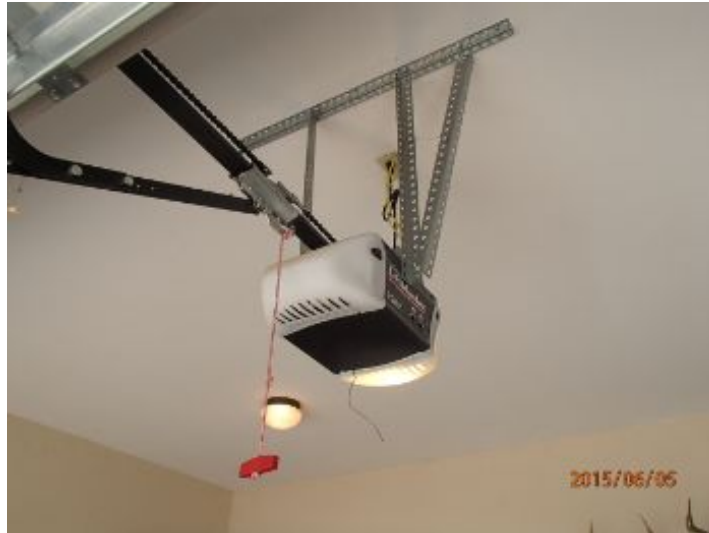
Functional. Adjustment needed to closing force of operator

- operated
- Eye beam system present, functional at time of inspection.
- Testing the garage door for proper operation of the reverse tension safety feature by applying upward pressure while door is lowering revealed that it needs adjusting or is not a feature of the tested opener to enhance safety to occupants/children. Recommend repair/adjustment or upgrading older opener to provide enhanced safety to occupants and guests.

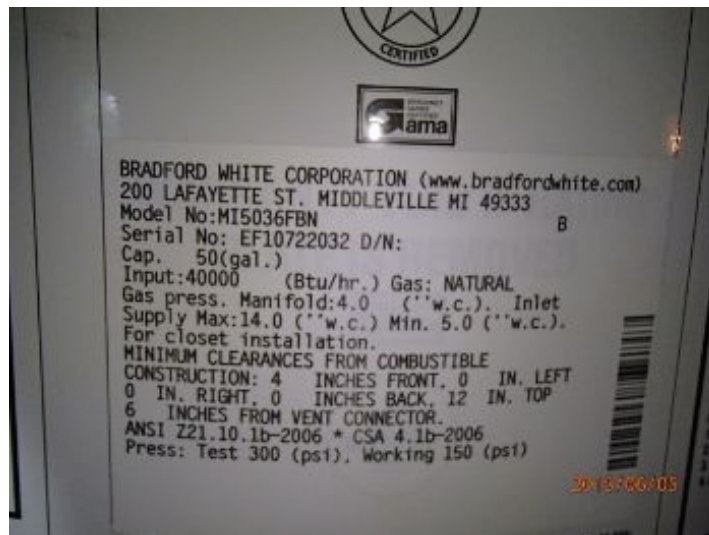
- Typical lifespan of a domestic water heater is 7-12 years. Unit could be nearing the end of its useful lifespan and fail without notice. Recommend budgeting for possible replacement in the near future.

Typical lifespan of a domestic water heater is 7-12 years. Unit could be nearing the end of its useful lifespan and fail without notice. Recommend budgeting for possible replacement in the near future.

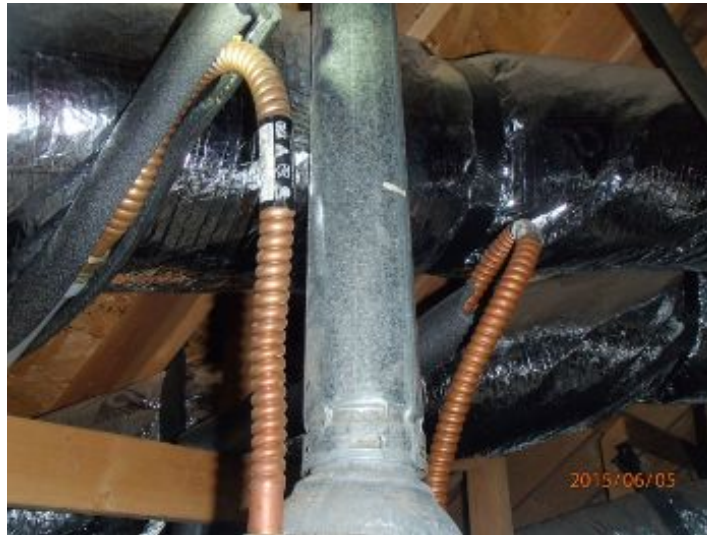
- Functional
- Vent pipe appears to lacks "minimum" 1 inch clearance from combustible materials, recommend review and repair by qualified contractor.

Flue pipe is to close to HVAC duct

Observations: Flue vent pipe appears to lack the proper 1 inch clearance from combustible. Recommend review and repair by a qualified contractor. (Flue pipe at water heater)

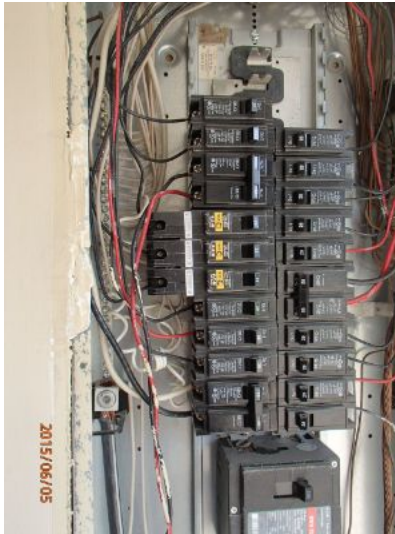
- Main shut off switch location is noted for future reference. Home owners should have this information in the event of an emergency.
- Circuits do not appear to be properly/completely labeled at dead front cover, recommend identifying and labeling ALL circuits for enhanced safety to occupants. The main disconnect breaker is especially important to locate quickly in case of an emergency.

Main shut off switch location is noted for future reference. Home owners should have this information in the event of an emergency.

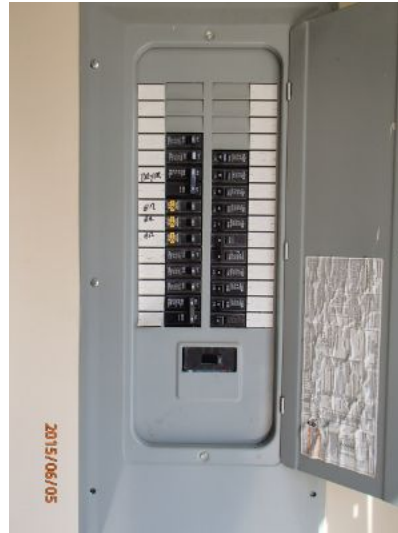
Label breakers

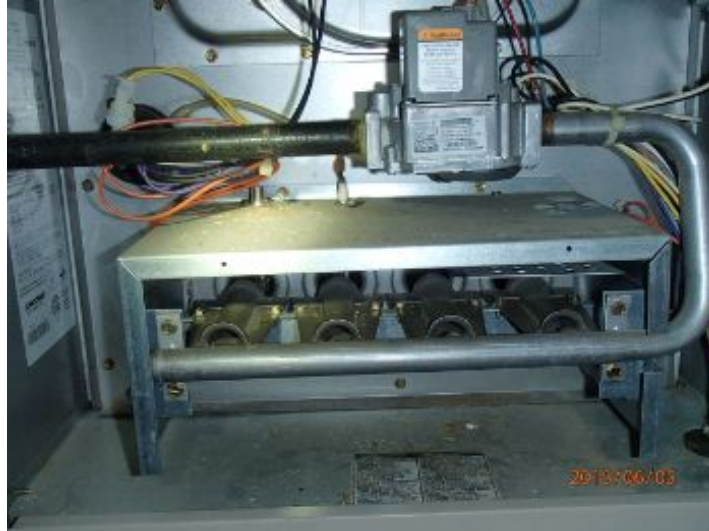
- Not operated due to outdoor temperatures.
- Unit does not appear to have been serviced annually per manufacturers instructions. Recommend having unit serviced annually to maintain efficiency and longevity of unit

HVAC equipment should be serviced at least once each year

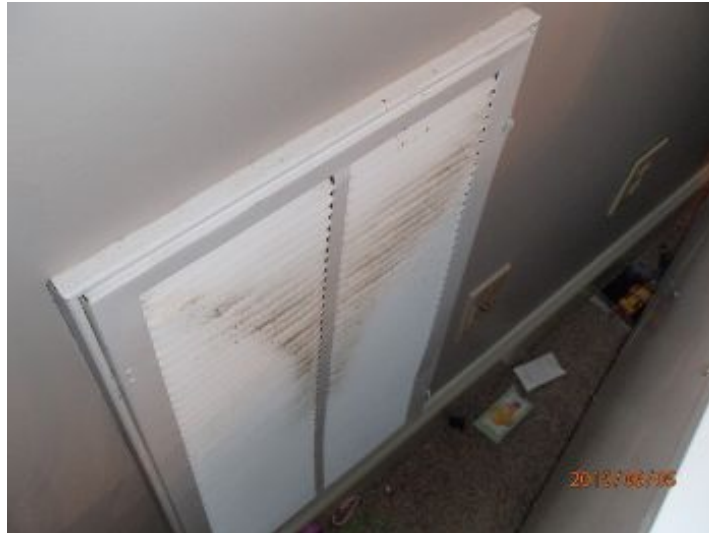
- Dirty filter noted, recommend replacement with a high quality pleated filter to enhance the indoor air quality for occupants.
- Recommend changing/cleaning filter monthly in heating season to enhance air quality as well as extending the furnaces lifespan.

Return air grilles in all bedrooms. Change filters each 30 days

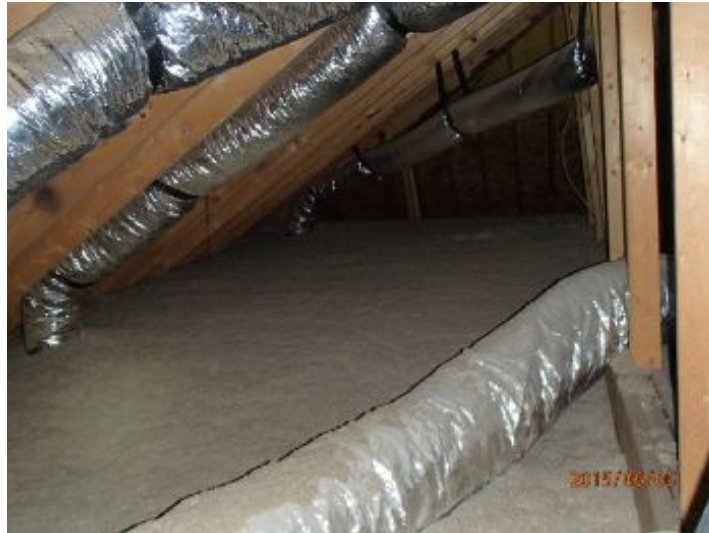
Heat/AC Ductwork

Observations:
• Recommend sealing all gaps, cracks and holes in the HVAC duct system for increased efficiency and lower energy bills.

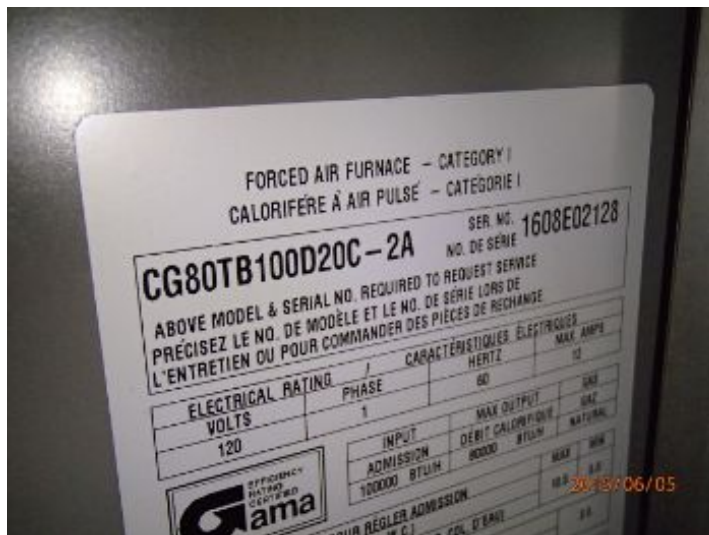
Furnace manufactured in 2008

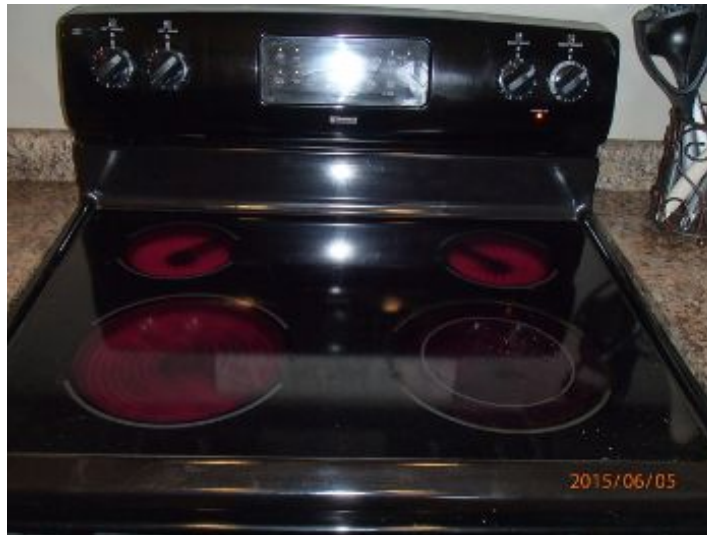
Observations:
• Functional at time of inspection
• Electric
• **No anti tip bracket installed on range.**

Anti tip bracket needed at range

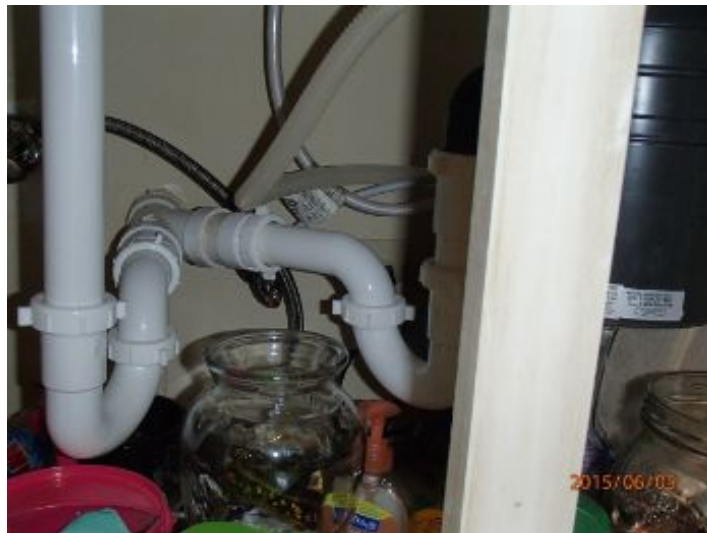
Kitchen Plumbing

Observations:
• Personal belongings prevented inspection of much of the plumbing areas under sink. Recommend review of plumbing pipes for areas of damage or leaks before the close of escrow.
